# Sherwood Arboretum Kauri Pine Decline

## Review and Options Paper

Water Management Team  
Parks Policy & Planning and Public Space Operations  
CA23/686640

April 2024

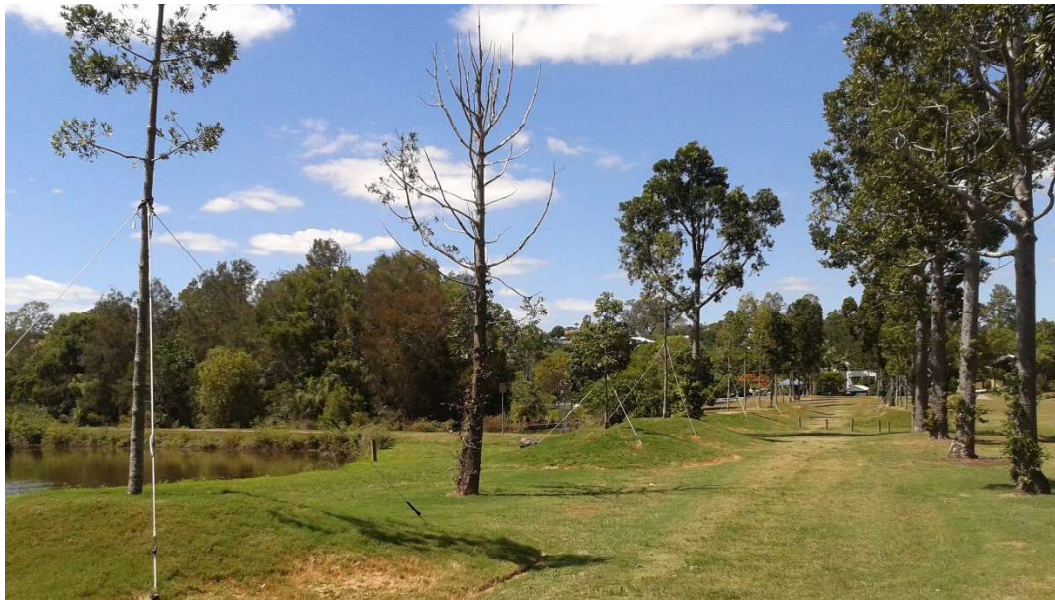
The declines have included the trees displaying a general lack of vigour, with reduced crown growth. The image of the dying trees in (Figure 6) is representative of the current declines including the two most recent declines that have occurred on the elevated section of the southern Avenue next to the car park.

**Figure 6: Image of Typical Poor Condition Kauri Pine Tree in Sherwood Arboretum Avenue (2017)**

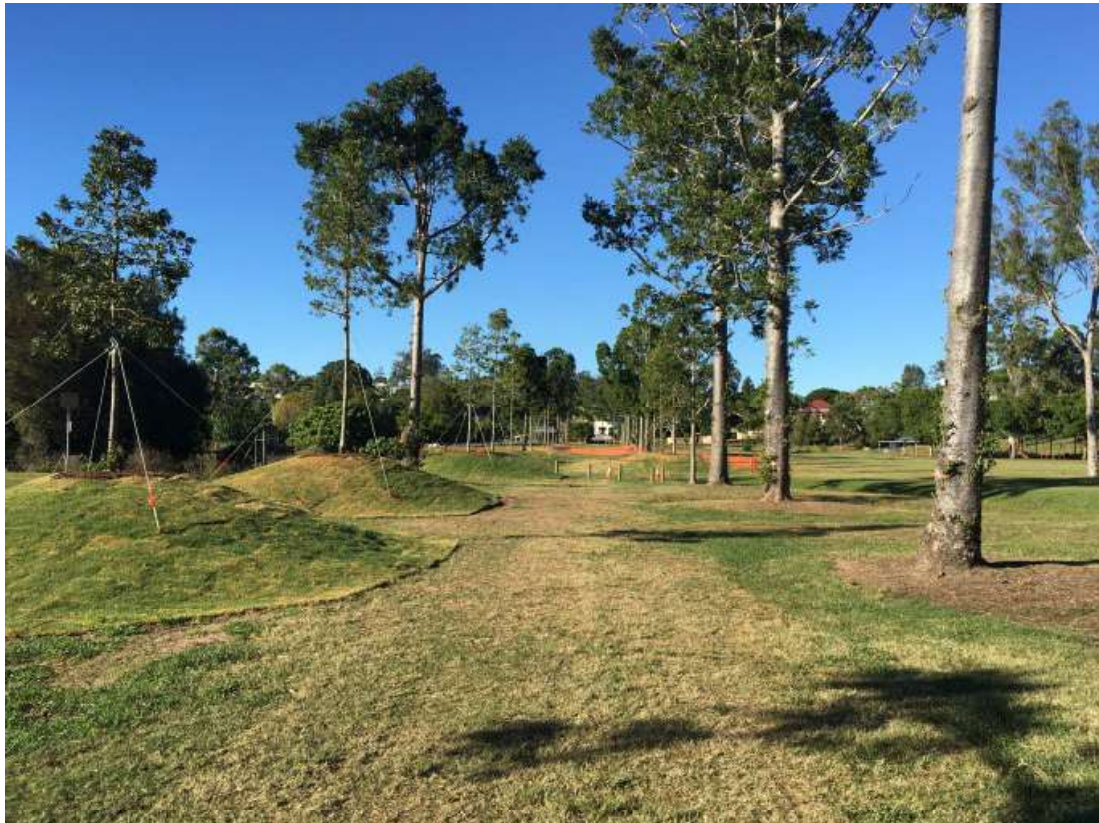
In 2014, a temporary measure, designed by Council's arborists, was to elevate the replacement trees in 'boxing' 400mm high. The boxing was removed in 2016, and the trees were placed in one metre mounds, to raise them above natural soil level (Figure 7). A total of 11 mounds were installed.

**Figure 7 Trees in one metre mounds on southern lying lowing section of the Avenue.**

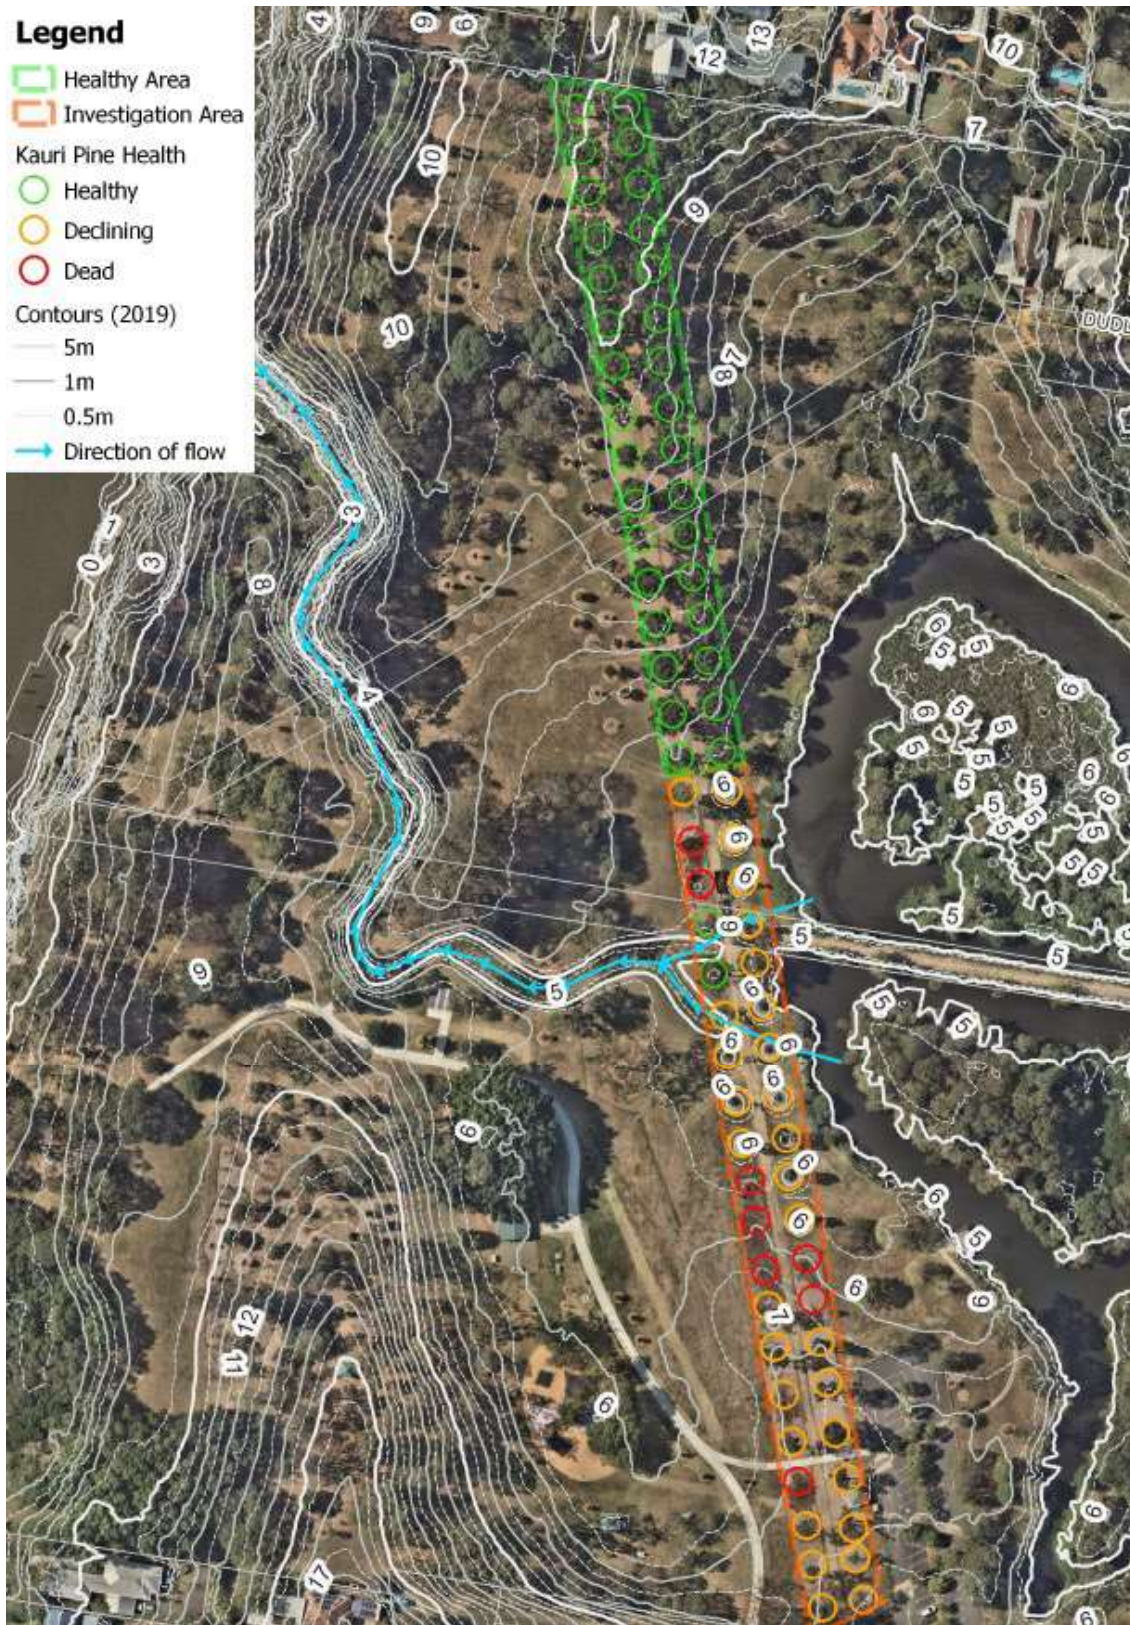
When the Avenue is viewed from an aerial perspective, some patterns can be observed relating to the health of the Kauri Pines (Figure 8). Kauri Pines in the northern portion of the Avenue above RL 6 m AHD, and up to approximately RL 9.5 m, appear in good health as shown by the green polygon and green circles around the trees in Figure 8. In contrast, most of the trees in the southern portion are in poor condition or dead, indicated by the orange and red circles in Figure 8. The measure of elevation is therefore not a critical factor in Kauri Pine decline as declining trees in the southern portion of the Avenue are above RL 6 m, as are healthy trees in the northern portion of the Avenue.

Two Kauri Pines on either side of the northern drainage channel marker in are in relatively good health, despite being in a low-lying area. They are sited at approximately RL 5 m and have a channel to the west that may be creating locally improved drainage and / or altered groundwater conditions.

The southern most portion appear to have declined relatively recently as viewed from aerial imagery. These specimens are located at approximately RL 7 – 7.5 m.

Figure 8 Map showing the extent of Kauri Pine decline. Red indicates dead trees, unhealthy trees in orange, and healthy specimens in green (October 2023).

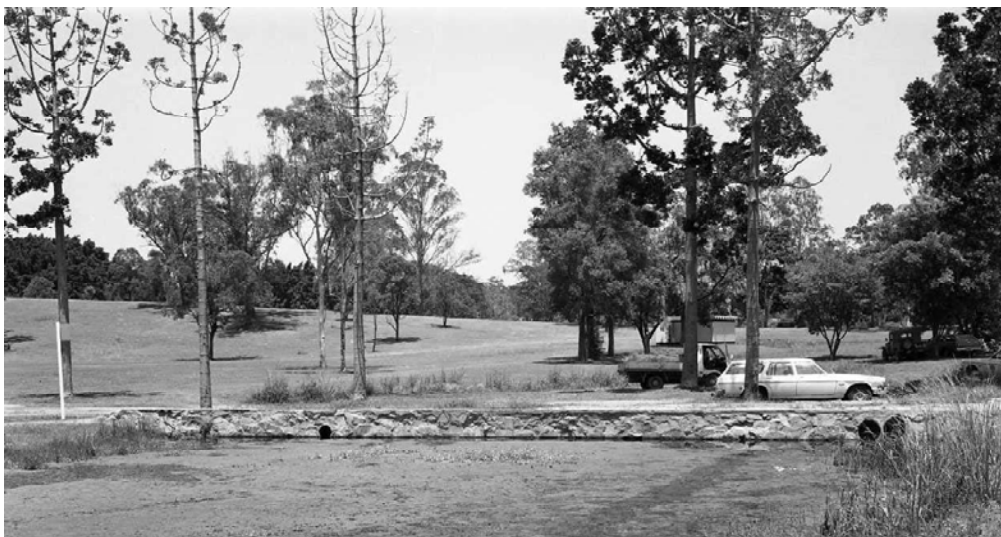
**Figure 10 Dead and dying Kauri Pines behind the wetland weir in 1976.**

The tree deaths in 1976 were most likely linked to the 1974 flood. Permanent wetlands were created during 1975-76 in an area of the Arboretum that was a low-lying wetland as indicated on the 1924 map of the Arboretum area (Figure 5).

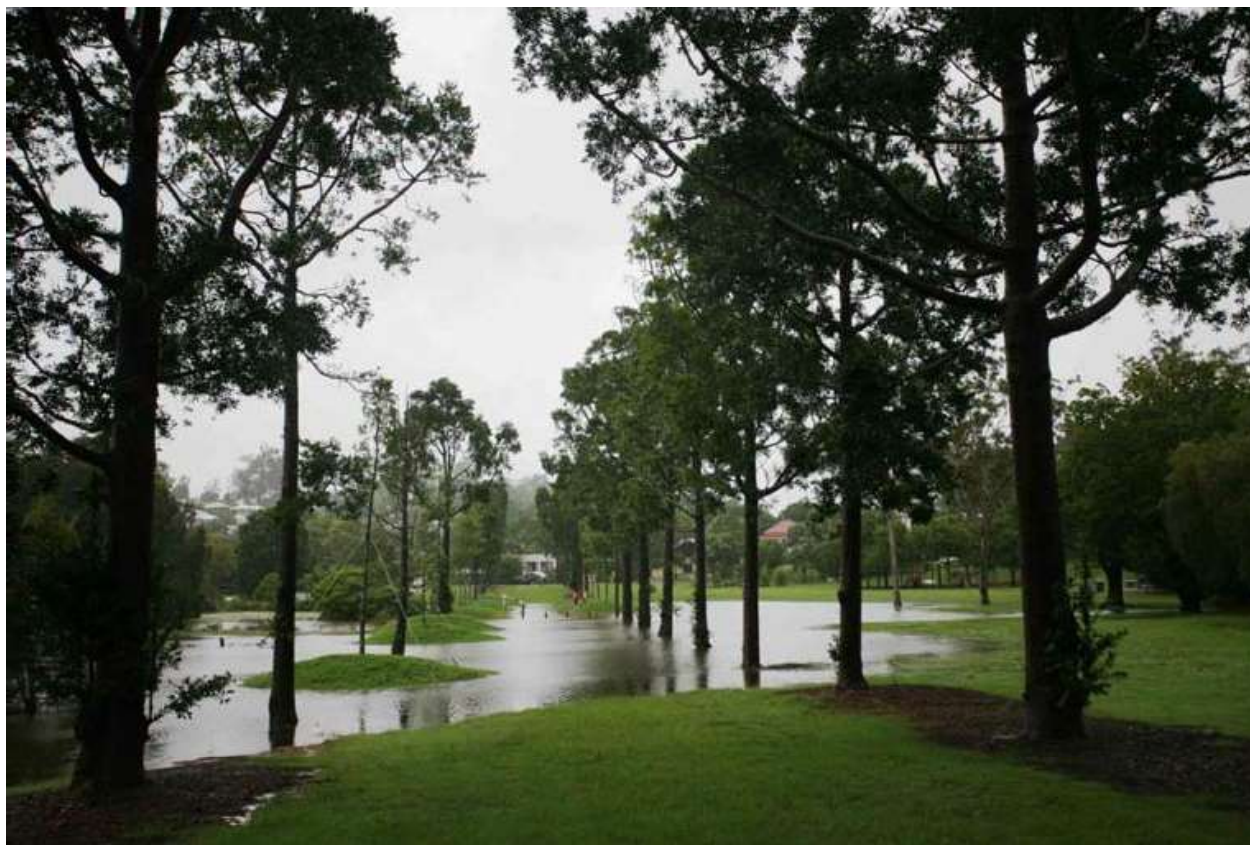
In 2017, following cyclone 'Debbie', the area was flooded again (Figure 11). An additional Kauri Pine declined and needed to be replaced as a result. This pine was replaced as a mounded tree in 2018, bringing the total number of mounded pines to 12.

**Figure 11 Low lying area of the Avenue during the 2017 flood (Source: Andrew Benison, FOSA).**

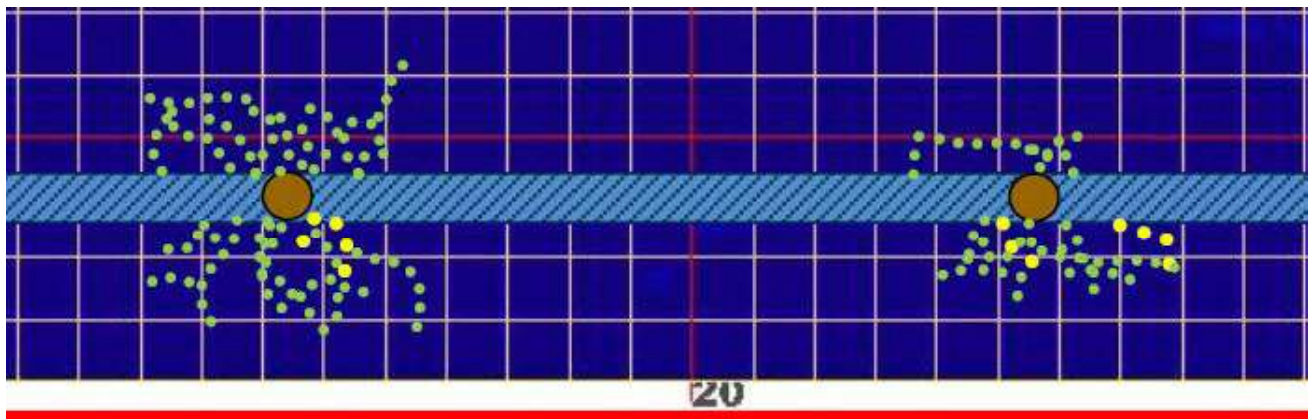
Figure 14 shows an extract of the outputs of the radar. The image shows roots between 5 – 65 cm below for trees 5 (Left) and 4 (Right). Most of the roots are less than 5 cm (Green), whilst some are 10 cm (Yellow).

**Figure 14: Typical results showing roots between 5-65 cm with an average size of 5 cm (Green), and some at 10 cm (Yellow). Grid size is 1 m.**
