# Sherwood Arboretum Kauri Pine Decline

## Review and Options Paper

Water Management Team  
Parks Policy & Planning and Public Space Operations  
CA23/686640

April 2024

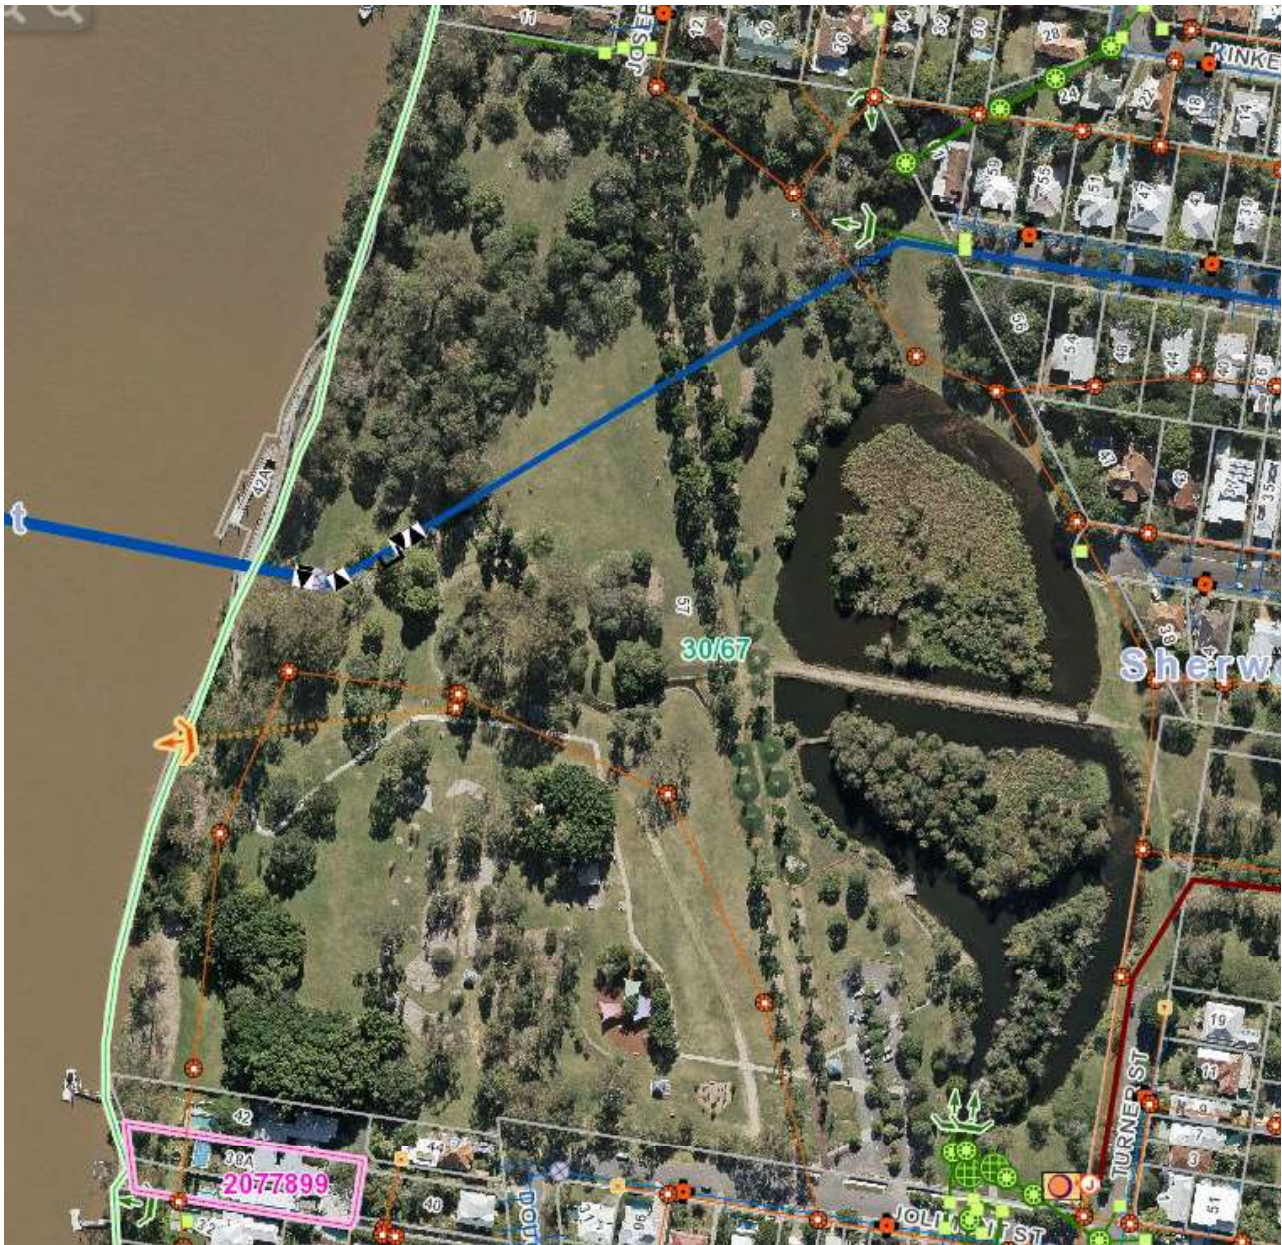
Figure 2: Surrounding Utilities (BCC Gecko) – Blue = Water main, Orange = Sewer

Public utilities are identified in the site adjacent to the Kauri Pines in the Arboretum. Figure 2 shows the public utilities within Sherwood Arboretum, where sewer (orange) approaches the Avenue in the south and water (blue) passes through in the north (Figure 2). The sewer is listed as asbestos cement with an invert level of approximately RL 3 m AHD (Relative Level (RL) of height using Australian Height Datum (AHD)) and average depth of 3.5 m. Its location would need consideration if any earthworks were planned.

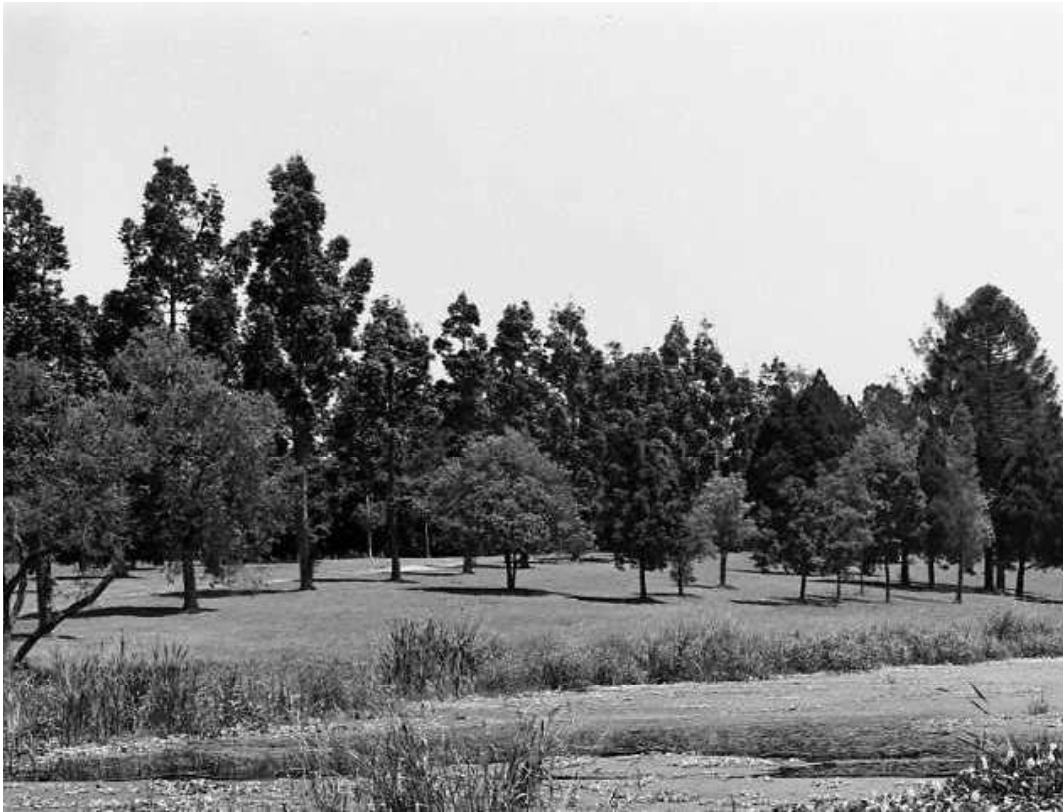
**Figure 9 Northern end of Sir Matthew Nathan Avenue (mid to back left of photo) in 1976 showing healthy trees.**

The floods have brought both water and silt to the site, which, when combined with the compact soil conditions, have had a major influence on the trees in the Avenue at the Arboretum. However, these impacts have mostly been restricted to the southern end. The photo below (Figure 9) from 1976 shows the healthy northern end of the Avenue after the major 1974 flood, however not the same can be said for the southern part of the Avenue shown in the photo below in the same year (Figure 10).

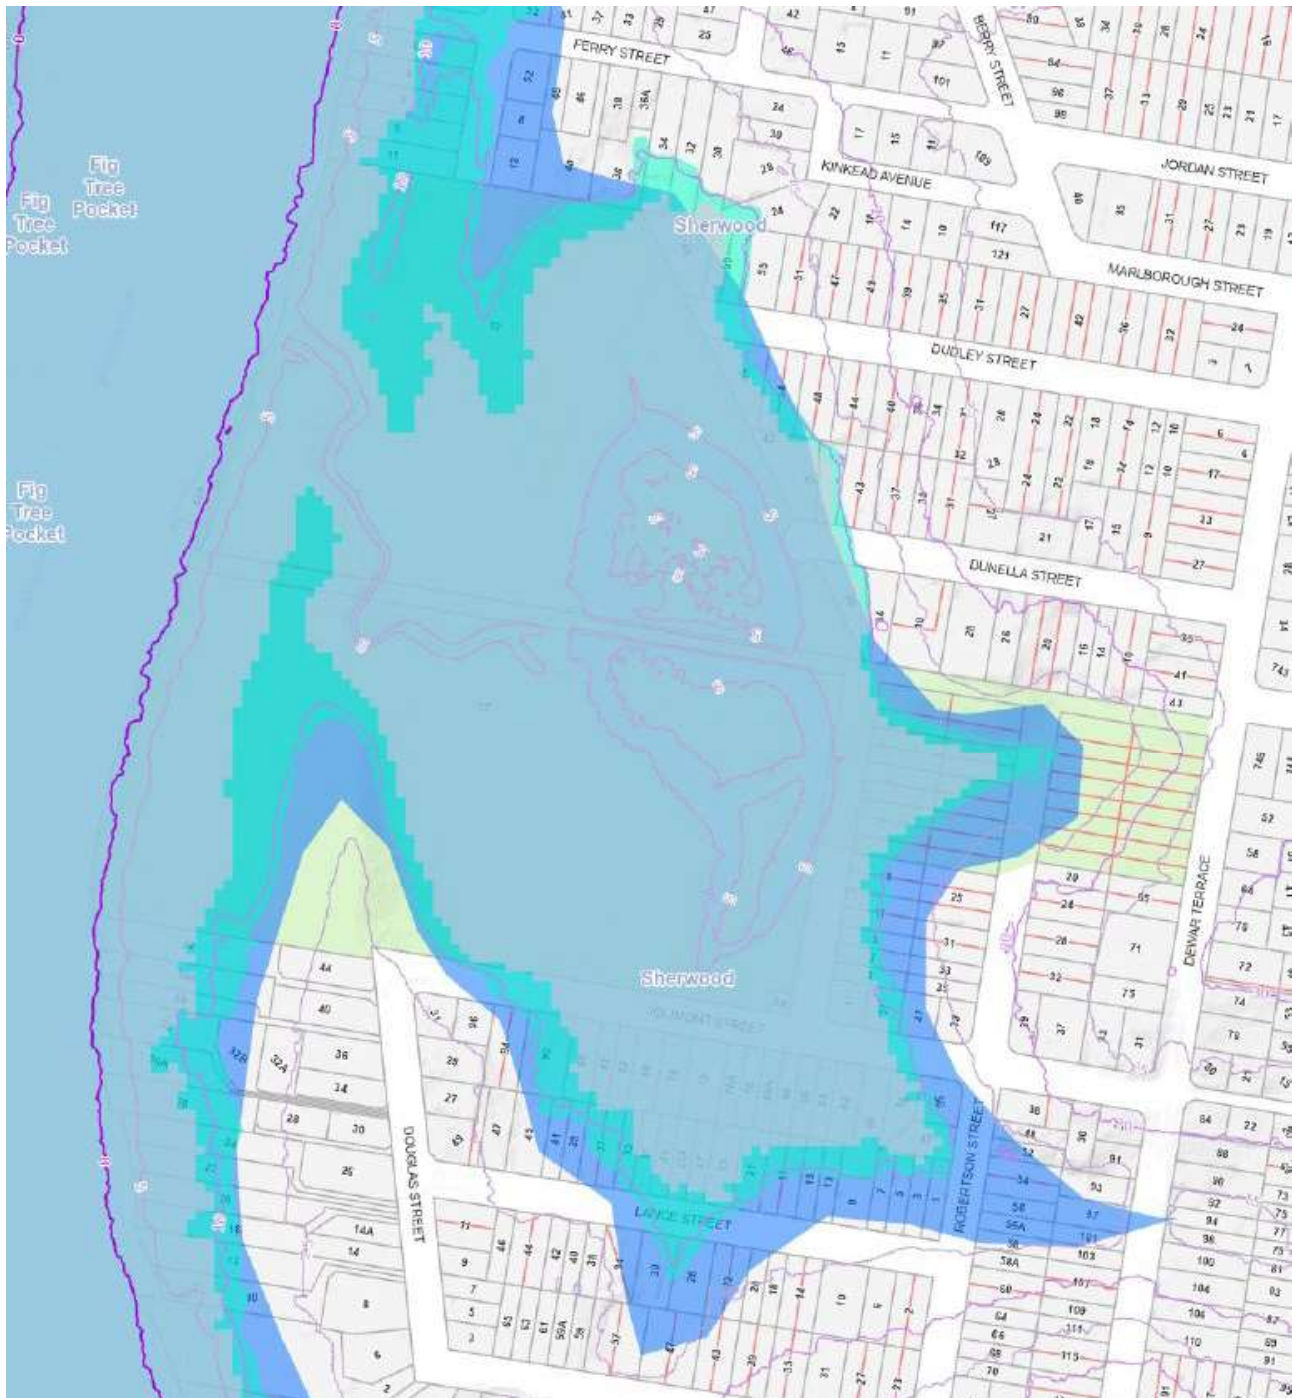
Figure 12: Major Historic Flood Events (Largest to smallest - 1974, 2011, 2022)

A summary of the extents of the 3 largest floods is presented in Figure 12. The 1974 flood is recorded having the largest extent, followed by 2011 and 2022, all of which inundated the whole of the Avenue including the healthy stand reaching an RL of approximately 10m AHD.

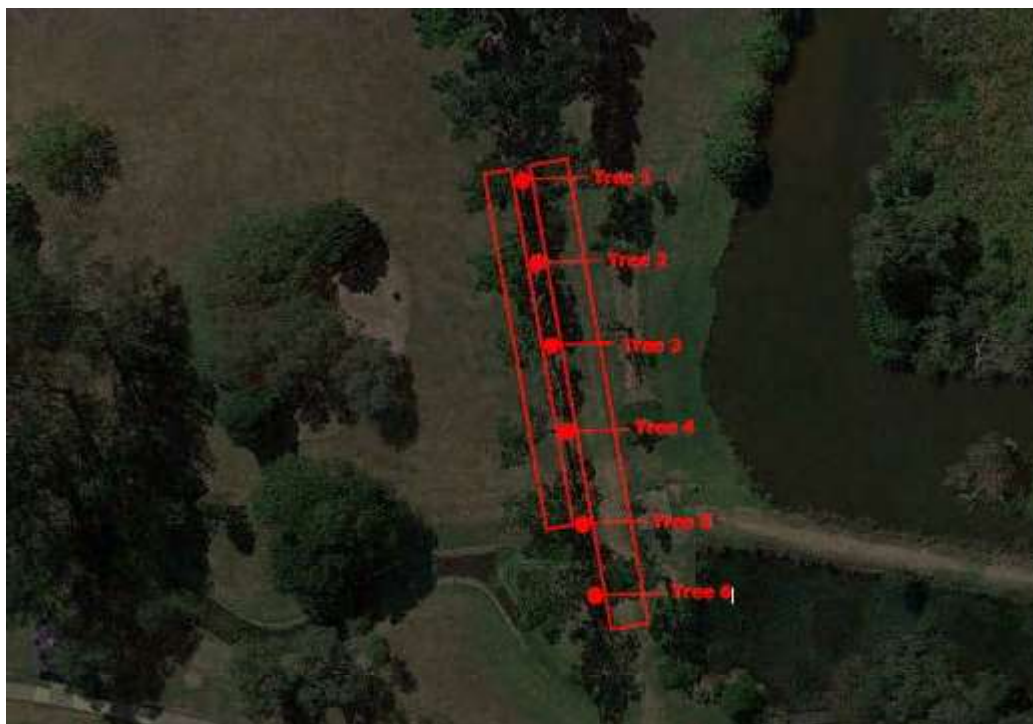
**Figure 13: Area surveyed using Ground Penetrating Radar**

Ground Penetrating Radar analysis was undertaken in 2017 by ENSPEC who surveyed 6 trees (ENSPEC Environment and Risk, 2017). The number of trees surveyed was limited due to unfavourable weather conditions at the time. The survey focused on the trees in the lower section of the Avenue just north of the gully on the west side (Figure 13) and identified:

- The trees had roots at 5 cm to 65 cm depth that were less than 10 cm in diameter
- The roots did not extend more than 3 - 4 metres from the centre of the tree.

Without comparative results from within the healthy stand, limited conclusions can be drawn about how the tree roots are impacted by the ground conditions. An Arborist was not able to provide any conclusions from this information, however, provided general advice to indicate that the extent of the roots is perhaps limited based on the size of the tree.

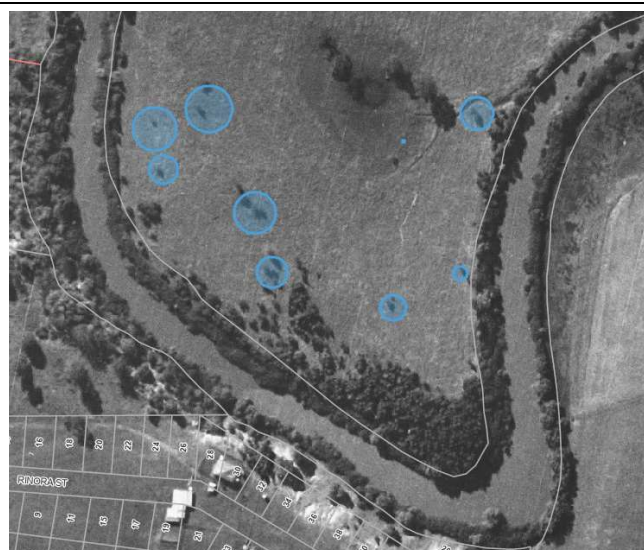
**Figure 16 Hoop pines at the Oxley 'Secret Forest' in 1946**

High levels (20,400 and 29,300  $\mu\text{S}/\text{cm}$ ) of EC were also found in the stand of Hoop Pines recently tested at the Oxley Common, Secret Forest Site. This site has been investigated to assess the suitability of Hoop Pines as a potential replacement species. Interestingly, the hoop pines appear to be in good health according to the Heritage Tree Care report (2023). Further to this, the stand appears to be still present in the 1946 aerial (Figure 16). Additional information on this site is provided in Section 3.4.

Figures 13 and 14 indicate the location of the Hoop pines and show the population has progressed well over the years. The Hoop pines were planted at the site around the same time as the Kauri Pines, but have not shown any losses, despite facing a similar flooding regime as the Arboretum.

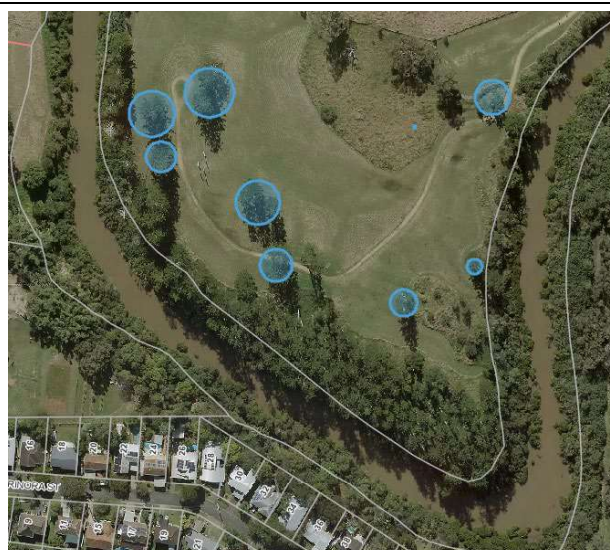
**Figure 17 Hoop pines at the Oxley Secret Forest - 2023.**

The stand of trees is located adjacent to brackish water, similar to the conditions at the Arboretum. Land elevations are similar but lower to those found at the Arboretum, with surface elevations of between 2 – 4 m AHD, whereas at the Avenue, the elevations range from 5.5 – 7 m within the southern section and up to 9 m AHD in the north.

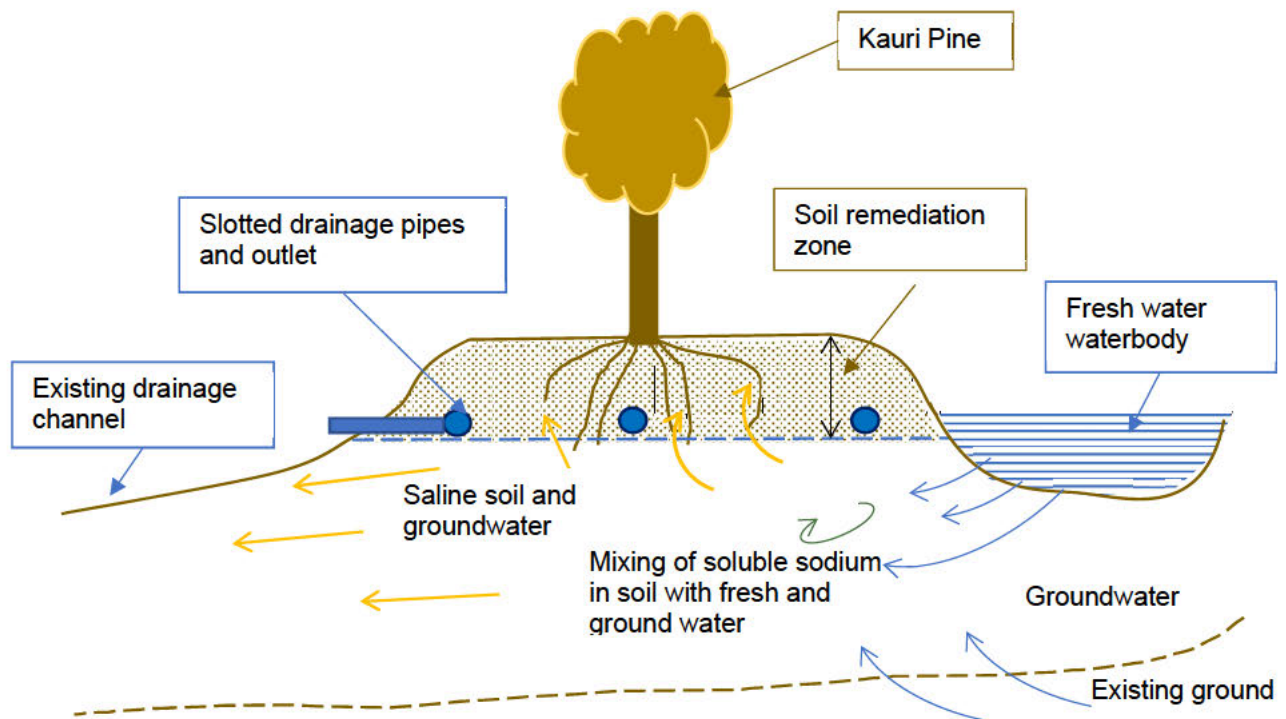
Figure 18: Diagram showing the predicted movement of groundwater and soil interactions.

Risks associated with this option are based on the solution itself and the nature and extent of the works required to achieve it. A substantial amount of soil (3500 m<sup>3</sup>) is required to be removed and replaced, which would require an estimated 600 truck movements in and out of the Arboretum. This volume of vehicle movement would impact residents, local roads, cause further compaction of soil and require a detailed traffic management plan for the Arboretum to minimise disruption to the use of the site. At a significantly increased cost, there is still the likelihood that salinity would enter and impact the new soil and with increased permeability, the soil would attract salt. These interactions are displayed in Figure 16. Additionally, with increased drainage, water would not be retained as easily.

Like Option 2.1, there is a risk associated with saline groundwater entering and interacting with the imported soil.
