Table C.2 Modified Cowan method for determining channel roughness

APPENDIX C

Natural Channel Design Guidelines

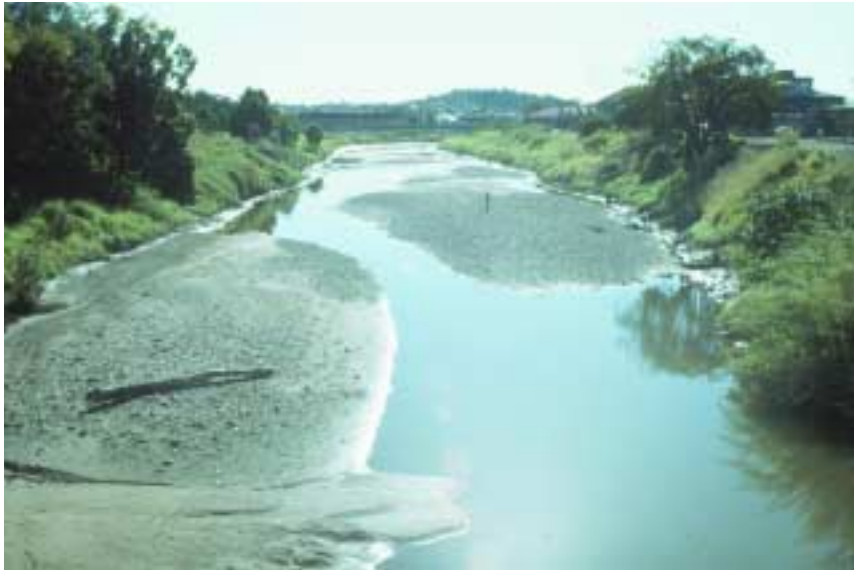
Photo C1

Straight, excavated, tidal channel.

Bed: $n = 0.02$

Banks: $n = 0.06$

Bankfull: $n = 0.024$

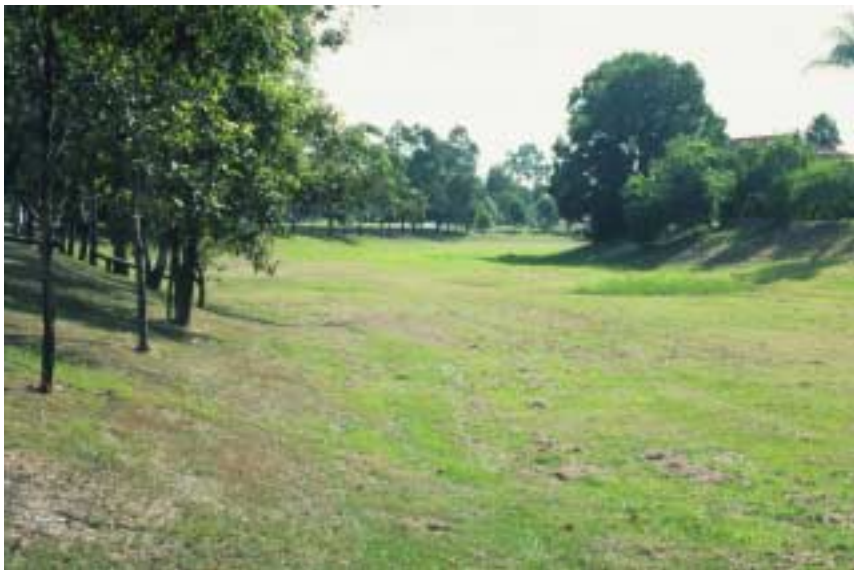
Photo C2

Slight meandering, regular cross section, well maintained grass channel.

Bankfull: $n = 0.028$

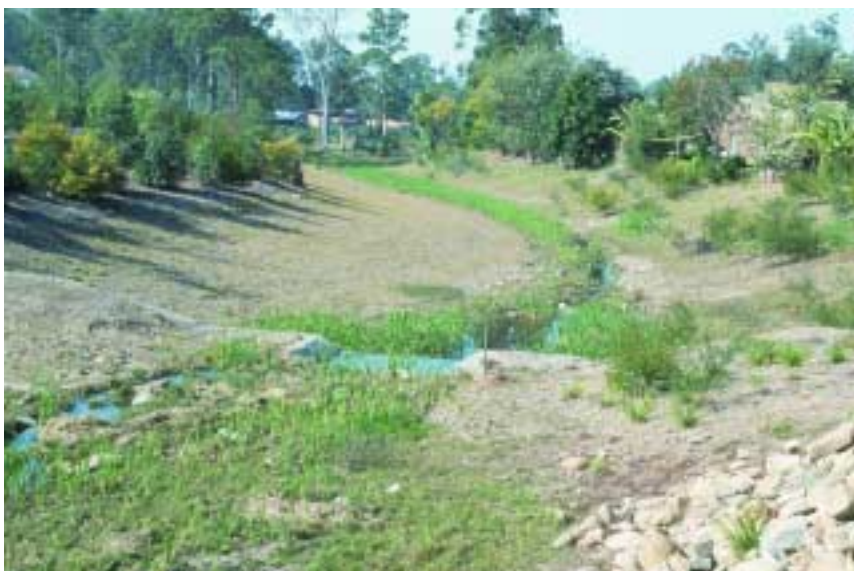
Photo C3

Mown grass channel, regular cross section, slight meander.

Bankfull: $n = 0.028$ (clean)

$n = 0.030$ (some shrubs)

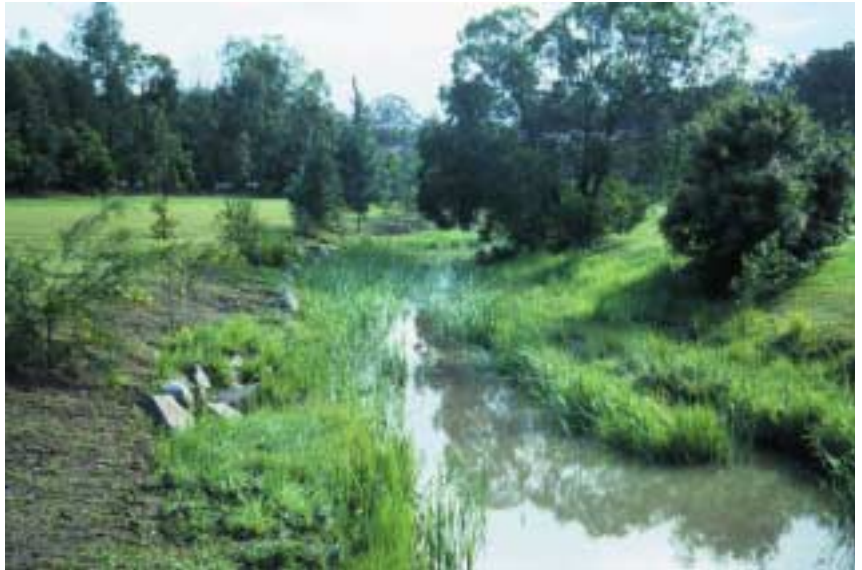
Photo C4

Regular cross section, slight meandering, mown overbanks.

Bankfull: $n = 0.04$

Overbank grass: $n = 0.03$ (shallow flow depth assumed)

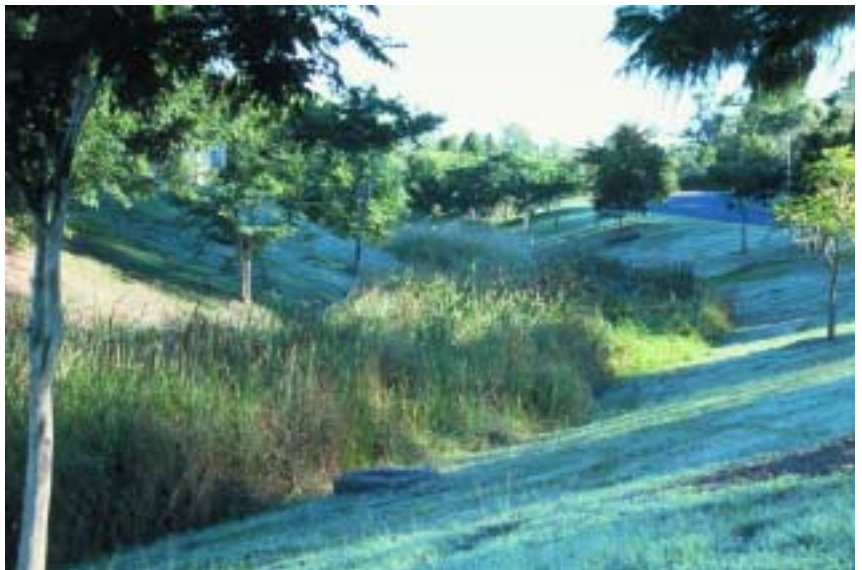
Photo C5

Mown grass banks, unmaintained wetland plants on bed, regular cross section, very slight meander.

Bed: Manning's n is variable depending on flow depth.

Bankfull components:

bed $n = 0.035$

bank $n = 0.030$

resulting in a bankfull $n = 0.035$

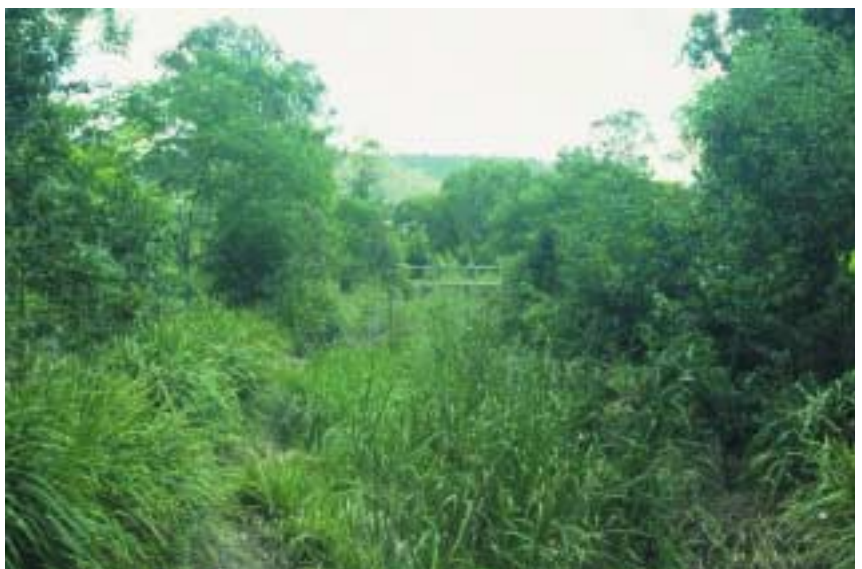
Photo C6

Canopy trees in early stages of growth, straight, regular channel.

Bankfull: $n = 0.04$

Overbank: $n = 0.15$

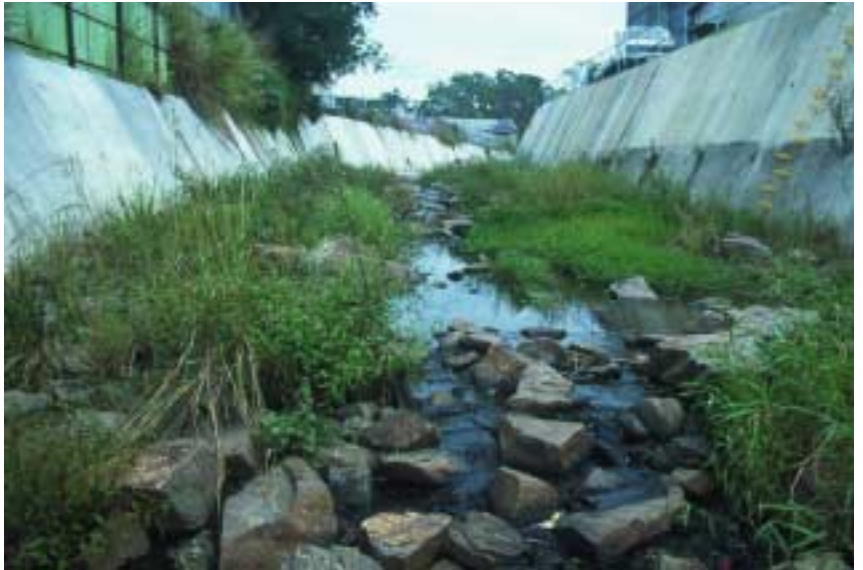
Photo C7

Rock size approx. 300 mm, this results in a Manning's $n = 0.034$ assuming deep water flow.

Bed: $n = 0.04$

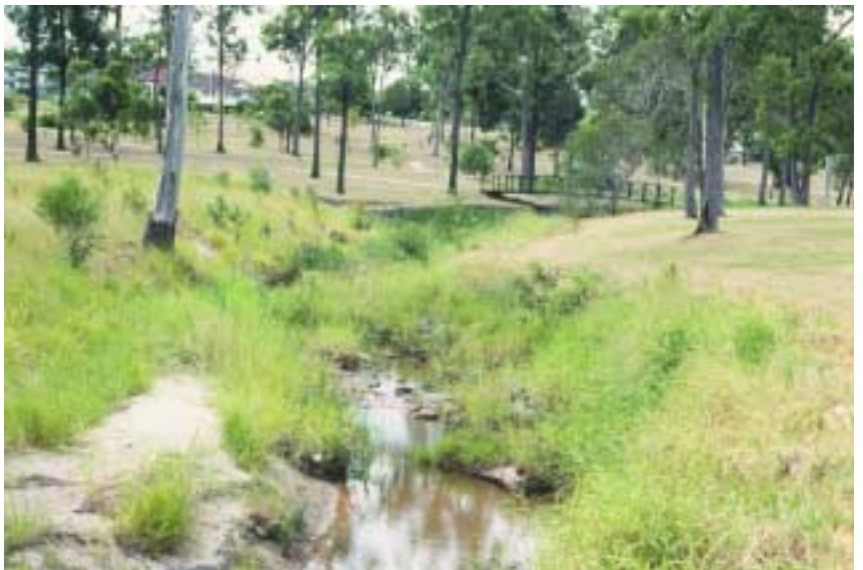
Photo C8

Deep channel, irregular cross section, meandering channel.

Bankfull: $n = 0.045$

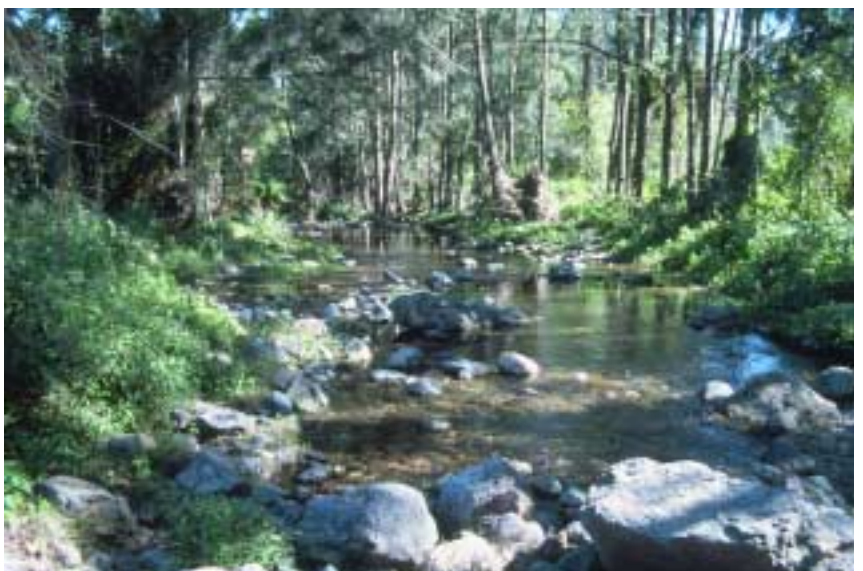
Photo C9

Near straight channel, full canopy cover with few weeds, pool-riffle system, shallow pools with boulders.

Bed: $n = 0.045$

Bank: $n = 0.09$

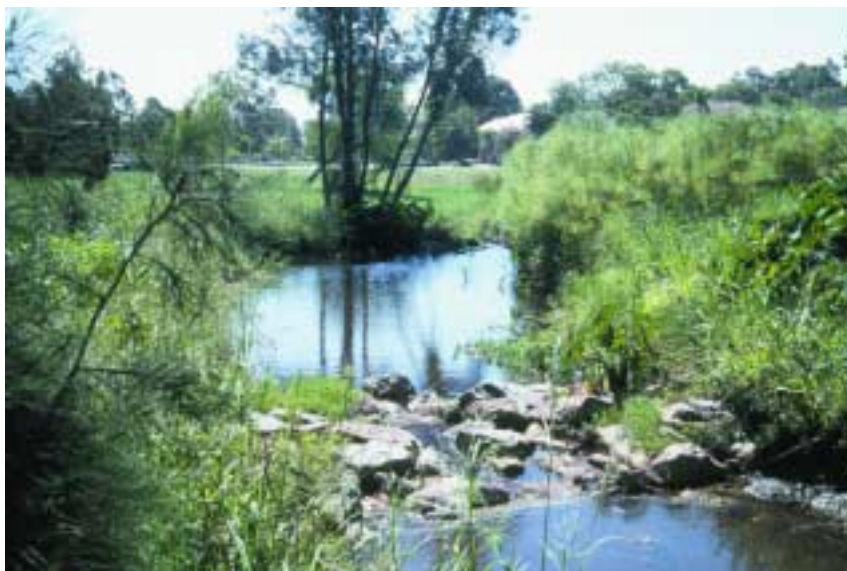
Photo C10

Pool-riffle bed system, meandering channel, thick shrub growth on banks, deep pools.

Bed: $n = 0.04$

Left bank: $n = 0.06$

Right bank: $n = 0.20$

Bankfull: $n = 0.06$

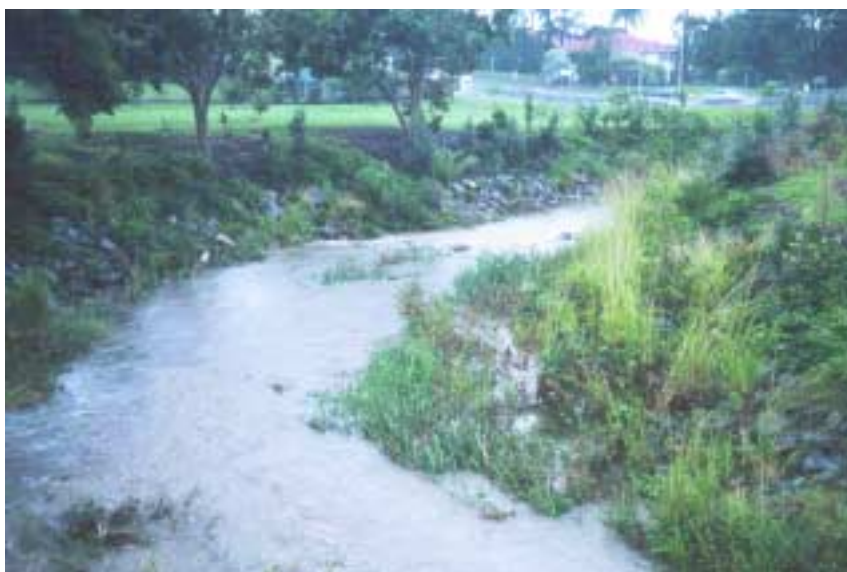
Photo C11

Channel vegetation in early growth stage, gradual bends, regular cross section, deep water, pool-riffle system.

Bankfull (existing): $n = 0.04$

Long-term (full vegetation) bed: $n = 0.05$

banks: $n = 0.15$

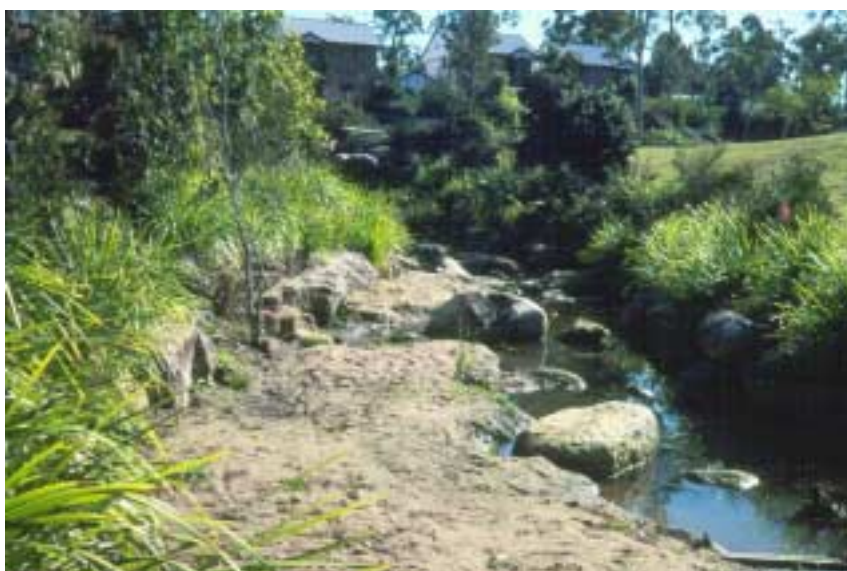
Photo C12

Irregular, meandering, constructed channel with boulders.

Bankfull: $n = 0.05$

Bank vegetation: $n = 0.15$

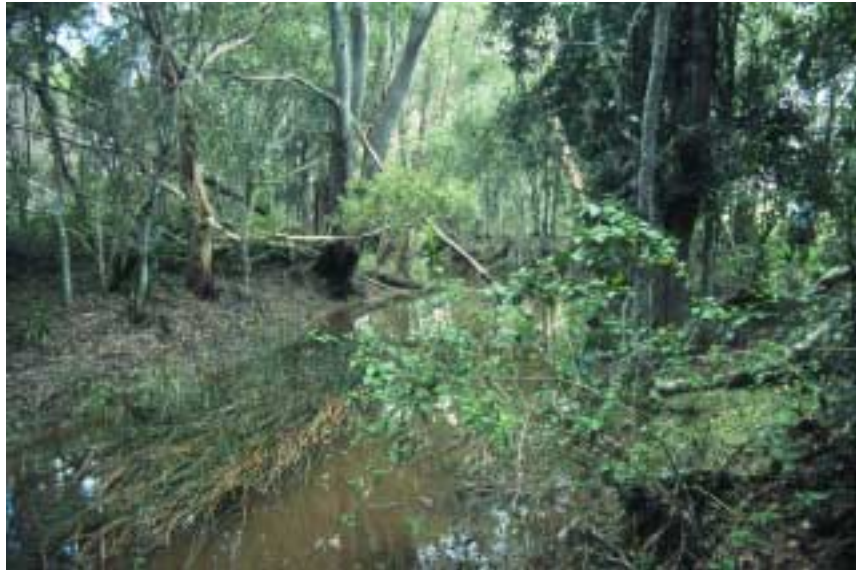
Photo C13

Irregular channel with meanders and woody debris (logs).

Bankfull: $n = 0.05$

Overbank: $n = 0.10$

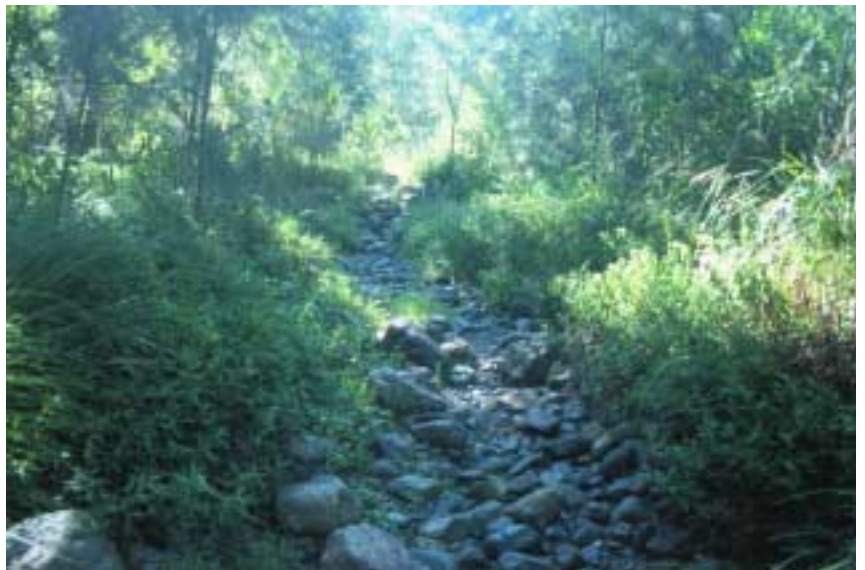
Photo C14

Bed is a combination of thick, flexible vegetation and open rock pools and riffles. banks have sparse trees and woody shrubs. Irregular channel shape with slight meandering.

Bed: $n = 0.06$

Bank: $n = 0.12$

Bankfull: $n = 0.07$

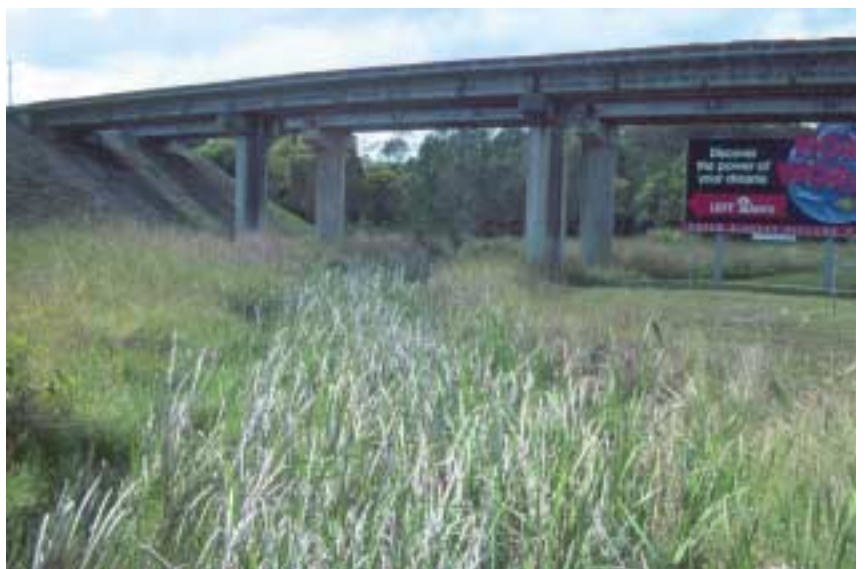
Photo C15

Weedy channel passing through a long grass floodplain. Irregular channel cross section with some meanders.

Bankfull: $n = 0.08$ (assuming low velocity and shallow depth that will not flatten reeds)

Overbank: $n = 0.03$ to 0.10

(depends on flow depth and velocity)

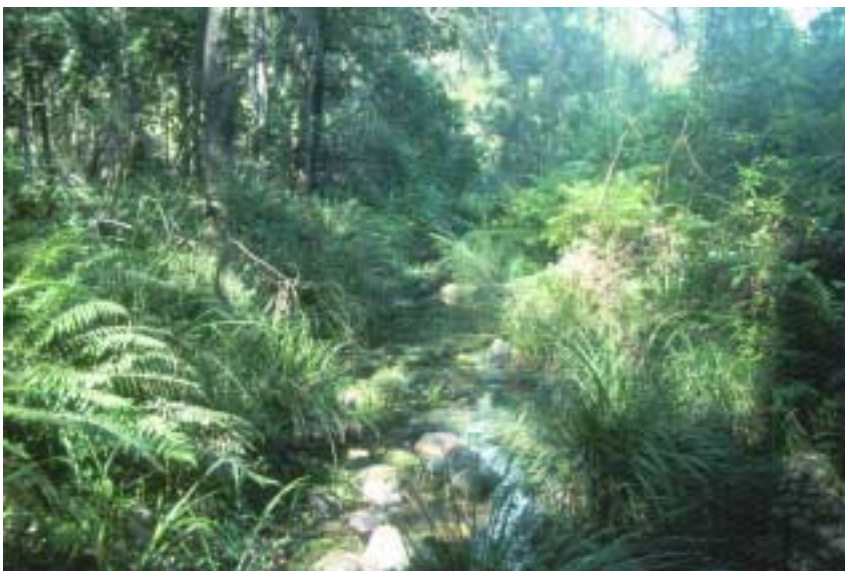
Photo C16

Irregular mountain creek with flexible understorey plants, few vines or woody shrubs.

Bankfull: $n = 0.10$ to 0.12

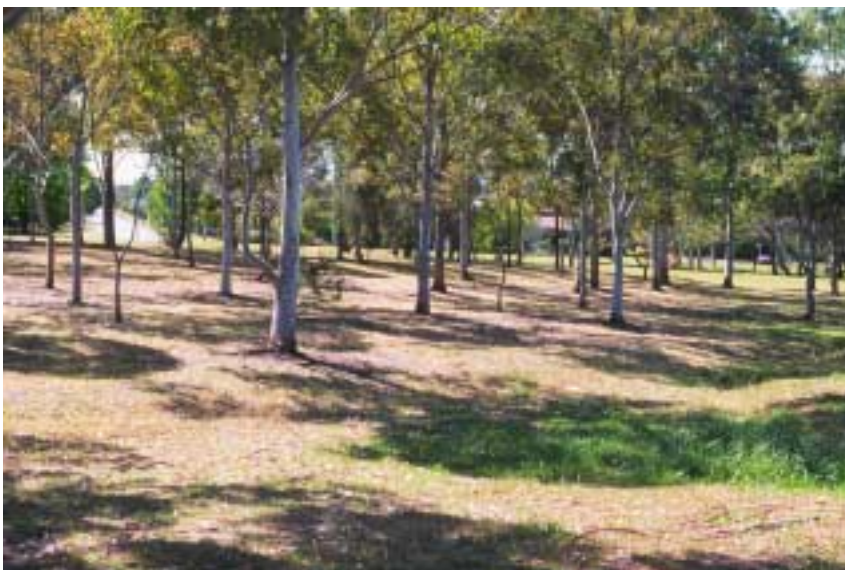
Photo C17

Overbank vegetation at approximately 8 metre spacing with no shrubs.

Overbank: $n = 0.05$

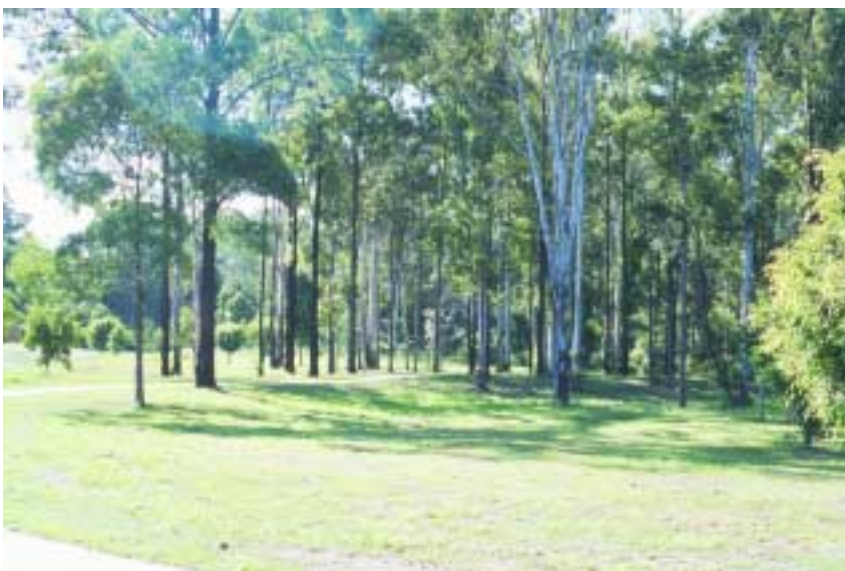
Photo C18

Overbank vegetation consists of tall truck trees, no low branches or shrubs. Tree spacing of approx. 8 metres.

Overbank: $n = 0.05$

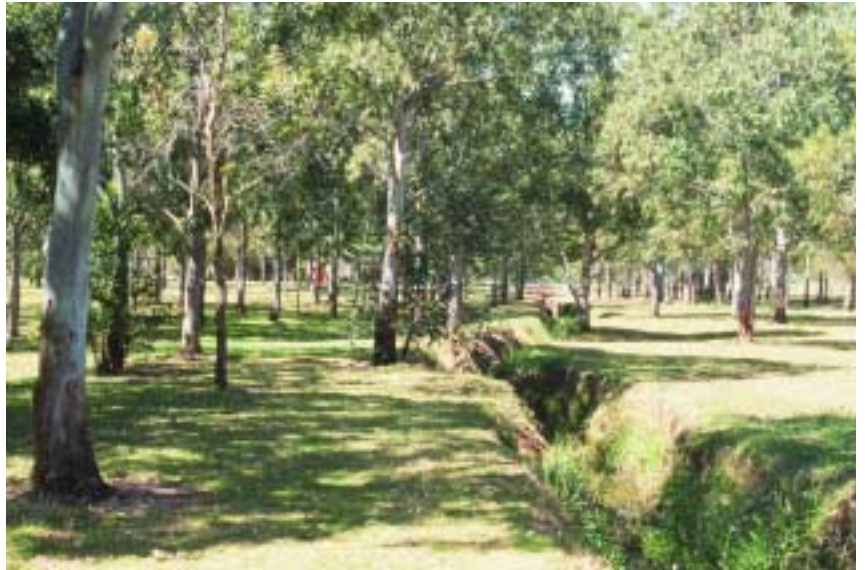
Photo C19

Irregular channel with meanders.

Channel: $n = 0.04$ to 0.05 depending on channel irregularity and debris content.

Overbank area consists of single truck trees with no low branches or shrubs.

LHS (5 m spacing): $n = 0.055$

RHS (6-7 m spacing): $n = 0.05$

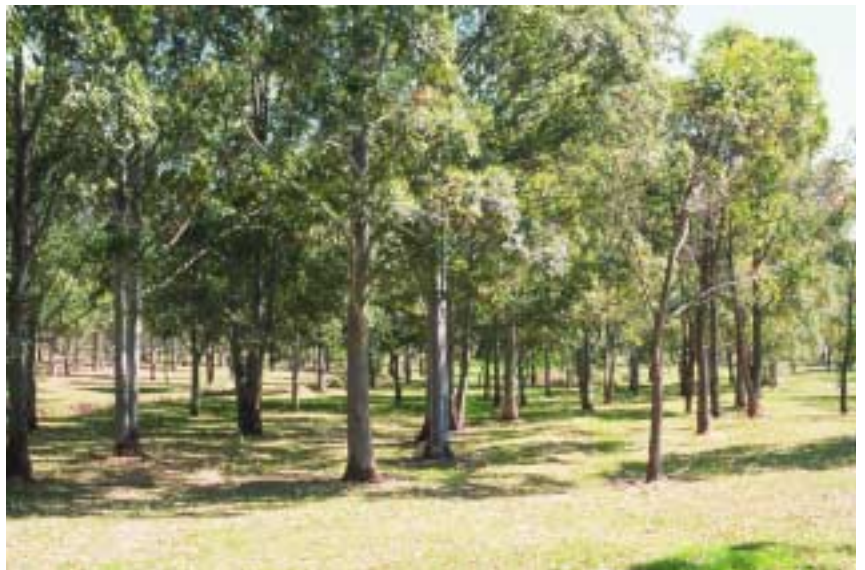
Photo C20

Trees at approx. 5 metre spacing, no low branches.

Overbank: $n = 0.055$

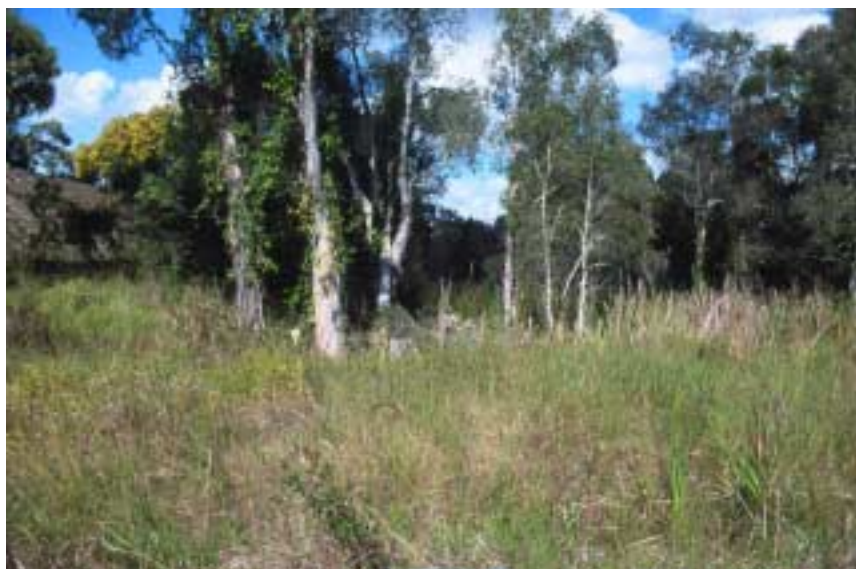
Photo C21

Irregular natural channel and wetland system with many weeds.

Overbank: $n = 0.06$
